Americanstruction Inc

# Roof System Certification - [REDACTED] [REDACTED], IL 60478

## Roof System Certification

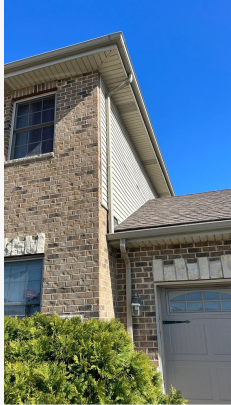
5

Perforated soffit panels are located periodically around the home and provide intake ventilation for the attic space.

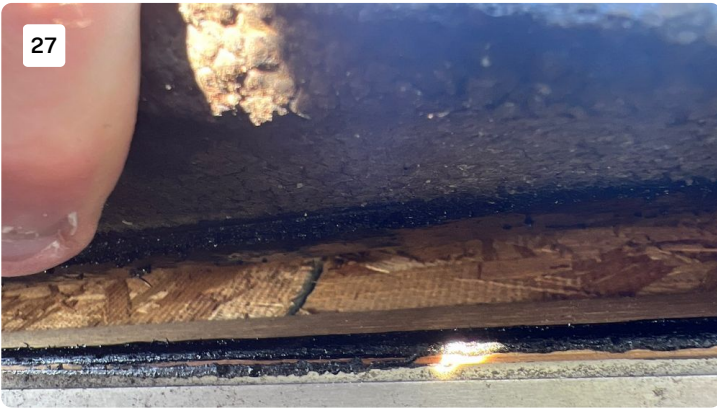
27

no ice and water shield

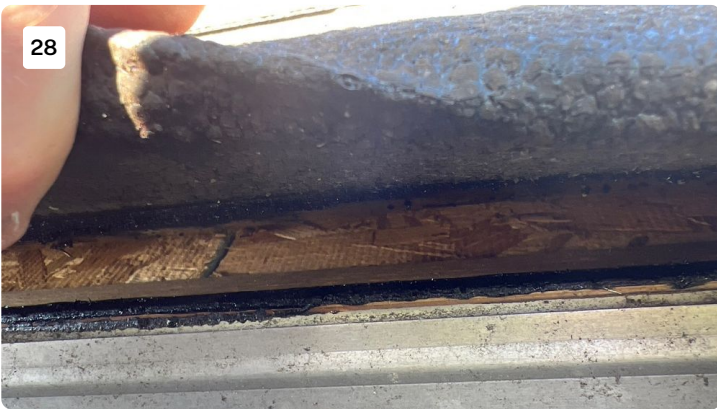
28

the bare wood is visible, no ice and water shield

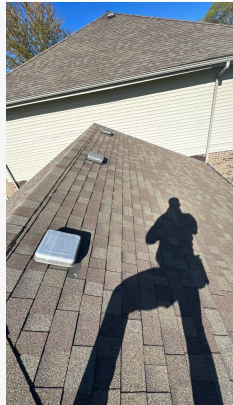
30

Turtle Vents are exhaust for the attic ventilation system.  
(7 COUNT box vents)

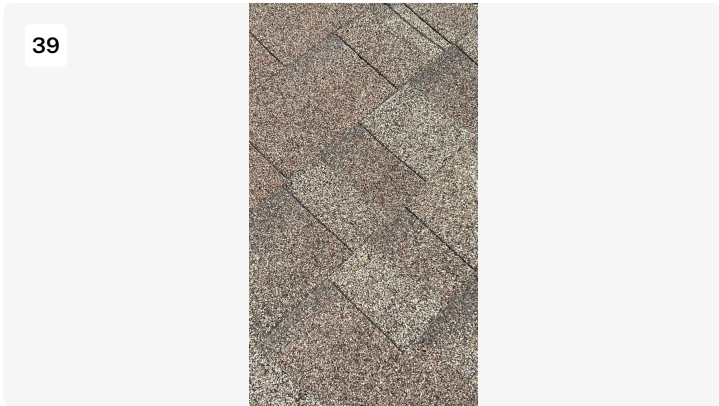
some general wear consistent with the age of the roof is present. This amount of granular loss is normal for a roof this age.

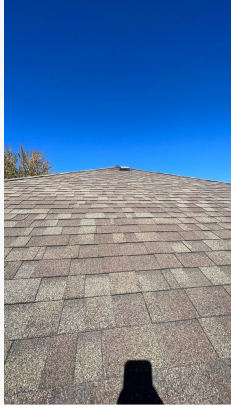
41

Overall the roof is in viable condition

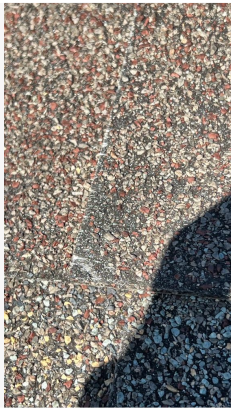
43

close up photo of wear and tear to the shingles

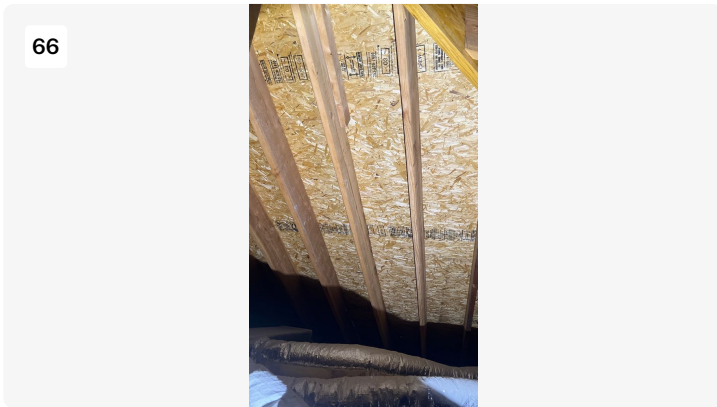
attic inspection: I did not observe any saturated sections of substrate

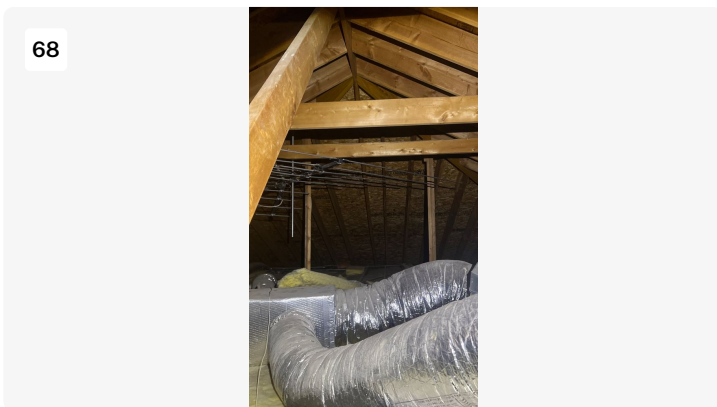
I noted that the attic was slightly warmer than I would have expected based on the 40-50degree exterior temperature
