Americanstruction Inc

# Roof System Certification - [REDACTED] [REDACTED], IL 60478

## Roof System Certification

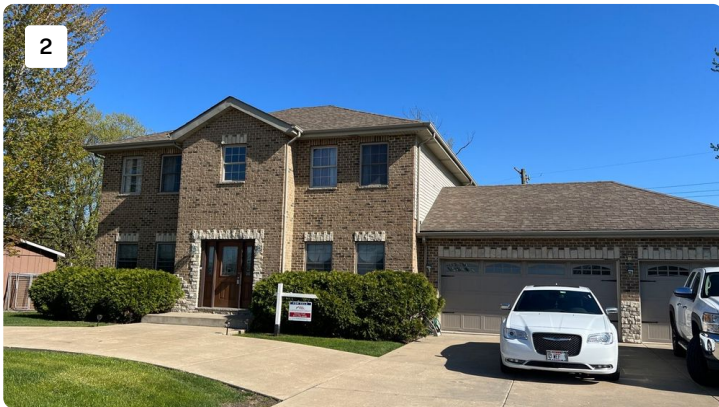
The first of the photos are simply my ground level inspection. I will include comments on any photos of significance where I am seeing some [REDACTED]
